Attachment C – Aerial Photo 1971 and 2 June 2009 Photos

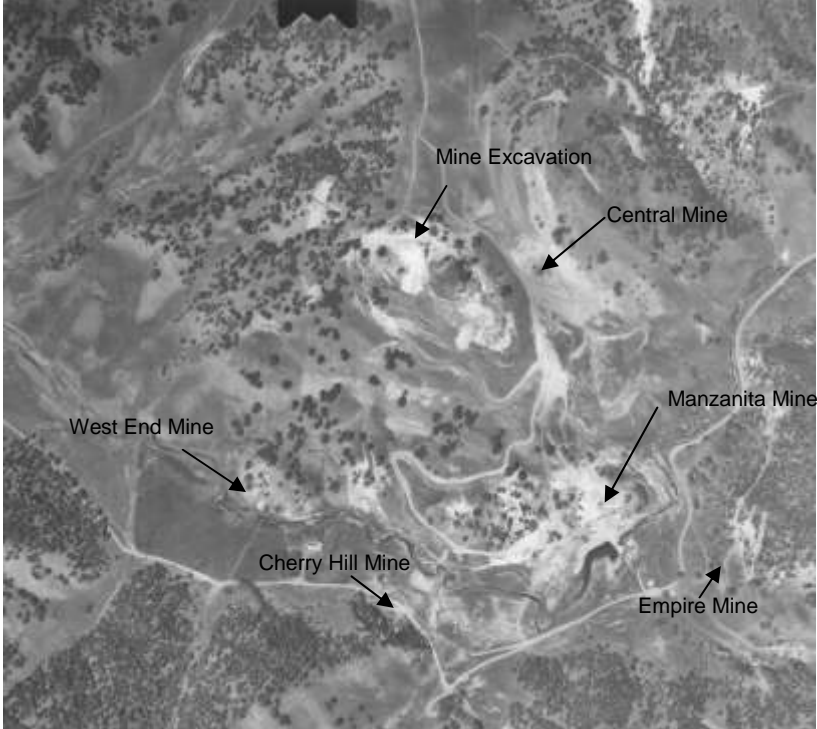
<p><b>Photo 1</b></p> <p>This is aerial photo taken in April 1971 and was obtain from the County of Colusa. This photo shows earth moving or excavation at Manzanita and Central Mines, and excavation directly west of Central Mine. Also note directly south of Manzanita Mine, Sulphur Creek has at least been partially dammed. Several roads cross Sulphur Creek.</p>

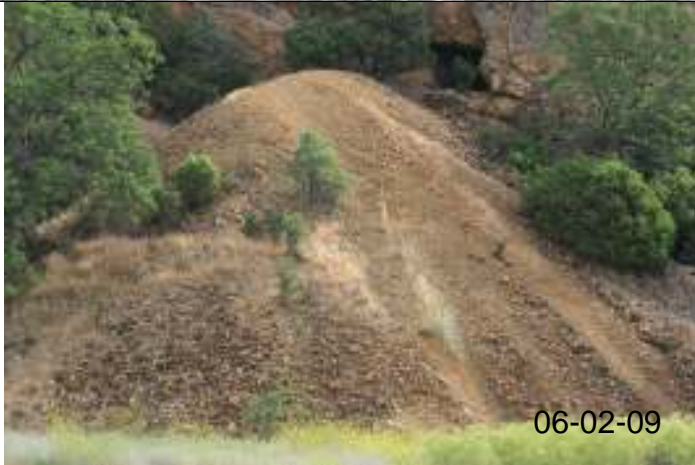
<p>This picture shows a mining waste rock pile and one of the portals at the West End Mine. The waste rock pile is very loose material and is susceptible to slope sliding and erosion. Sulphur Creek is between the photographer and the waste pile. Photo was taken by Victor Izzo.</p>

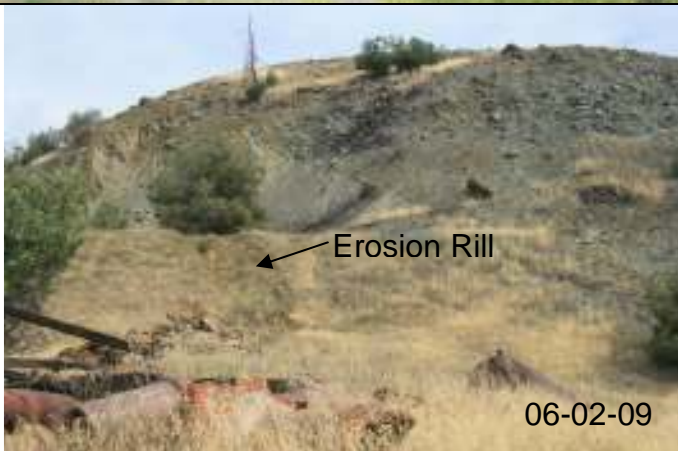
<p>This large open face is part of Central Mine. This cut was done in early 1970's and is a larger open slope that is susceptible to erosion. Also, note the erosion rill cutting through mining waste. This picture was taken looking north towards Central Mine. Photo was taken by Victor Izzo.</p>

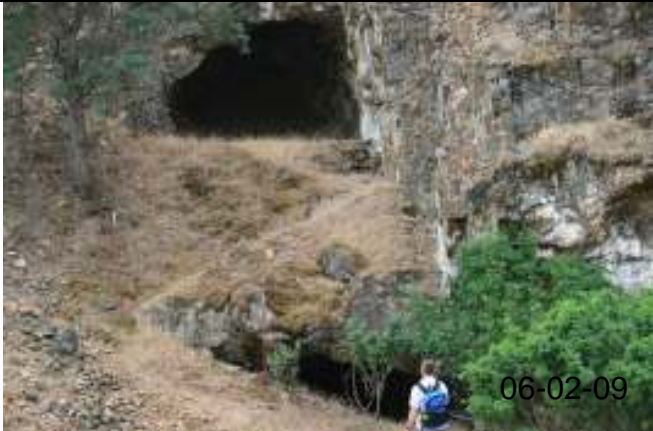
<p>This is two of the portals associated with Cherry Hill Mine. This mine is on a hill directly adjacent to Sulphur Creek flood plain. Waste material from this mine would or have been discharged to the Sulphur Creek Flood plain. This picture was taken from that plain looking southwest. Photo was taken by Victor Izzo.</p>

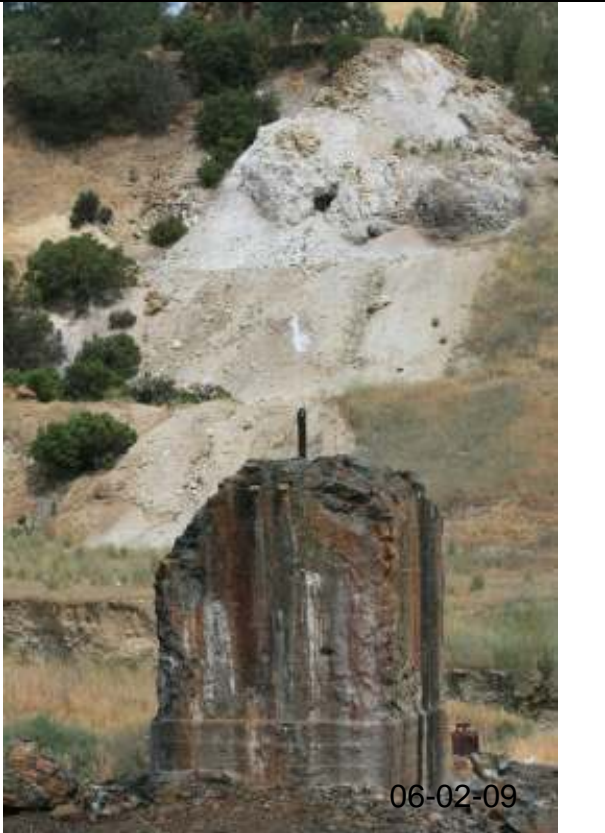
<p>The white slope and the adit are part of the Manzanita Mine. All this area is highly erodeable. Sulphur Creek is between the photographer and the slope. Also there are additional mine working above this visible mine slope that is apart of Manzanita Mine. This picture is looking south towards the mine. Photo was taken by Victor Izzo.</p>

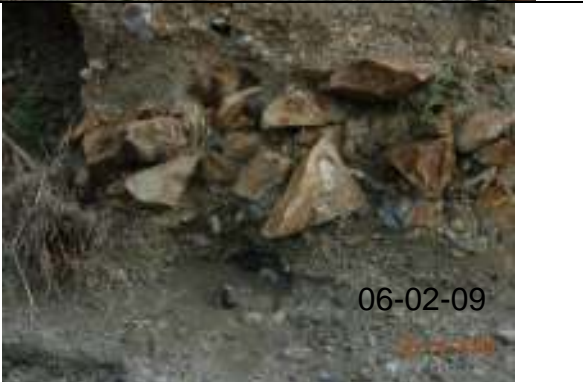
<p>This is a picture of angular rock in the bank of Sulphur Creek. This appears to be mining waste rock because it is not a typical stream flood plain deposit. This picture was taken directly south of Manzanita Mine. Photo was taken by Jeff Huggins.</p>
